Re: OFEO Project No.: 1124108, SIB – Earthquake repairs

Please find attached a copy of our Field report from the 1/31/12 site visit. This report summarizes our assessment of the plaster damage in the Secretary's Office and the Regent's Room caused by the earthquake.

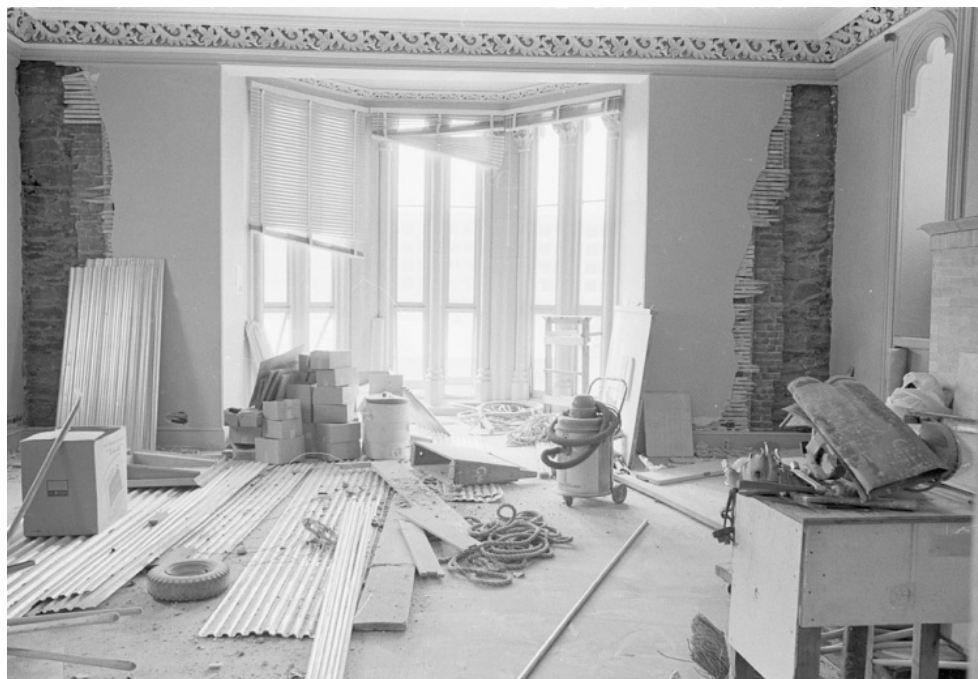
A probe in the Regent's Room was only done on the eastern side of the bay window (Figure 4) opening and similar cracks occurred on the western wall of the opening at the same location. Based on the probes (Figure 5) and previous renovation construction photos (Figure 6), the cracks on both sides of the framed opening at the bay window extension occurred due to discontinuities in the back-up support for the plaster finish.

Figure 6: Photo of Regent's Room renovation circa 1968 showing exposed interior wall construction.
