Re: OFEO Project No.: 1124108, SIB – Earthquake repairs

Please find attached a copy of our Field report from the 1/31/12 site visit. This report summarizes our assessment of the plaster damage in the Secretary's Office and the Regent's Room caused by the earthquake.

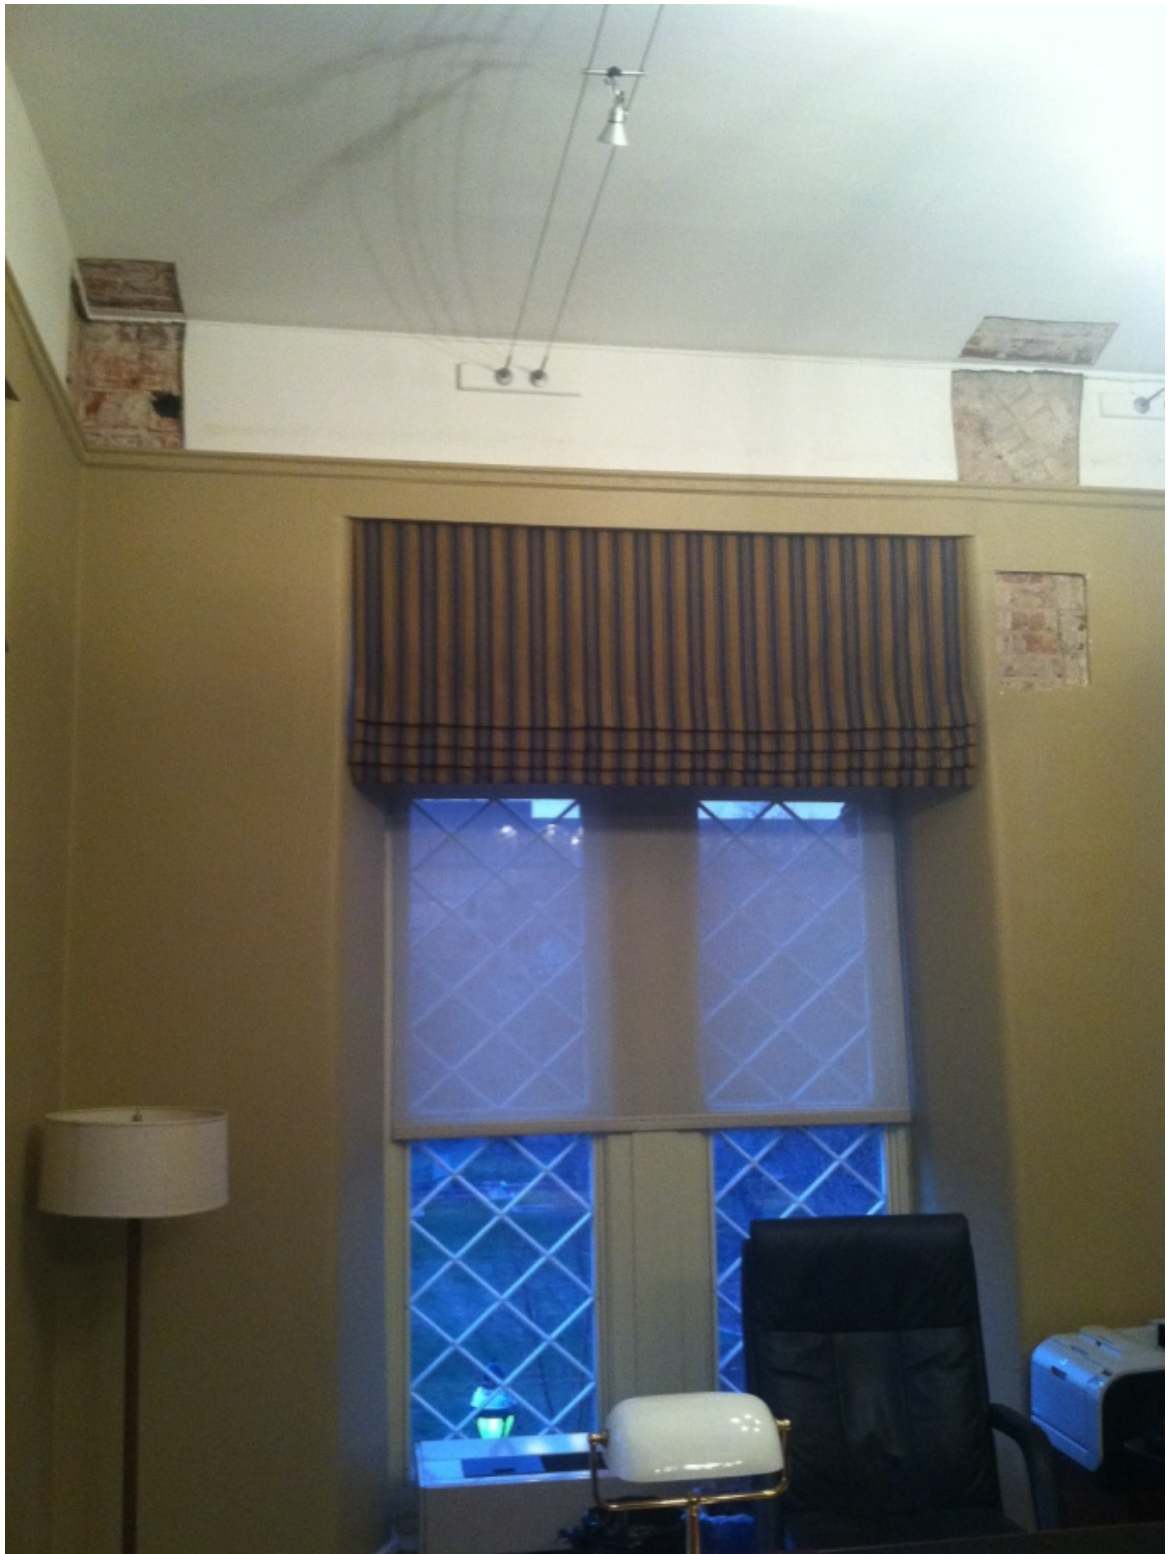
Figure 1: View of probe locations in Secretary's Office

The observed earthquake damage does not appear to present a structural problem. The structural integrity of the observed areas is in no worse state than the pre-earthquake condition; therefore, immediate corrective structural work does not appear to be required. The Smithsonian Institution should proceed with patching the plaster at the probe locations.

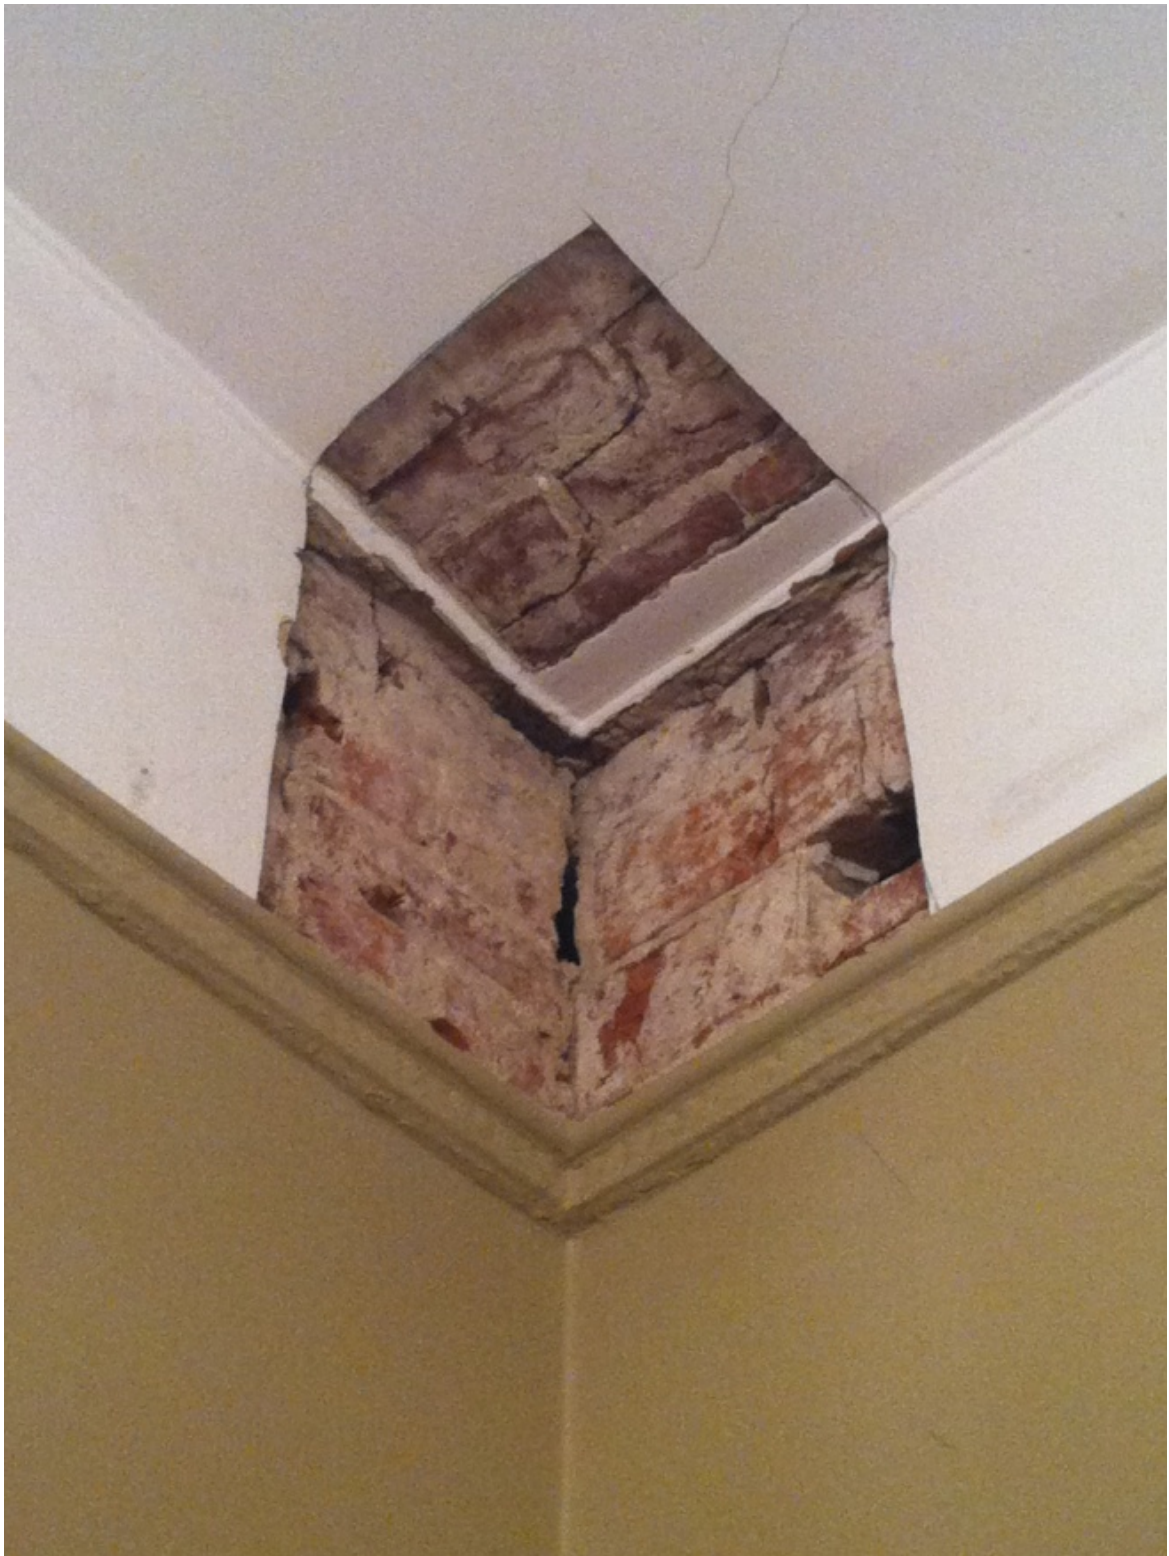
therefore more susceptible to cracking during the seismic event and subsequent broadcasting of the cracks through the finished plaster.

Figure 2: Probe in Southeast corner of Secretary's Office

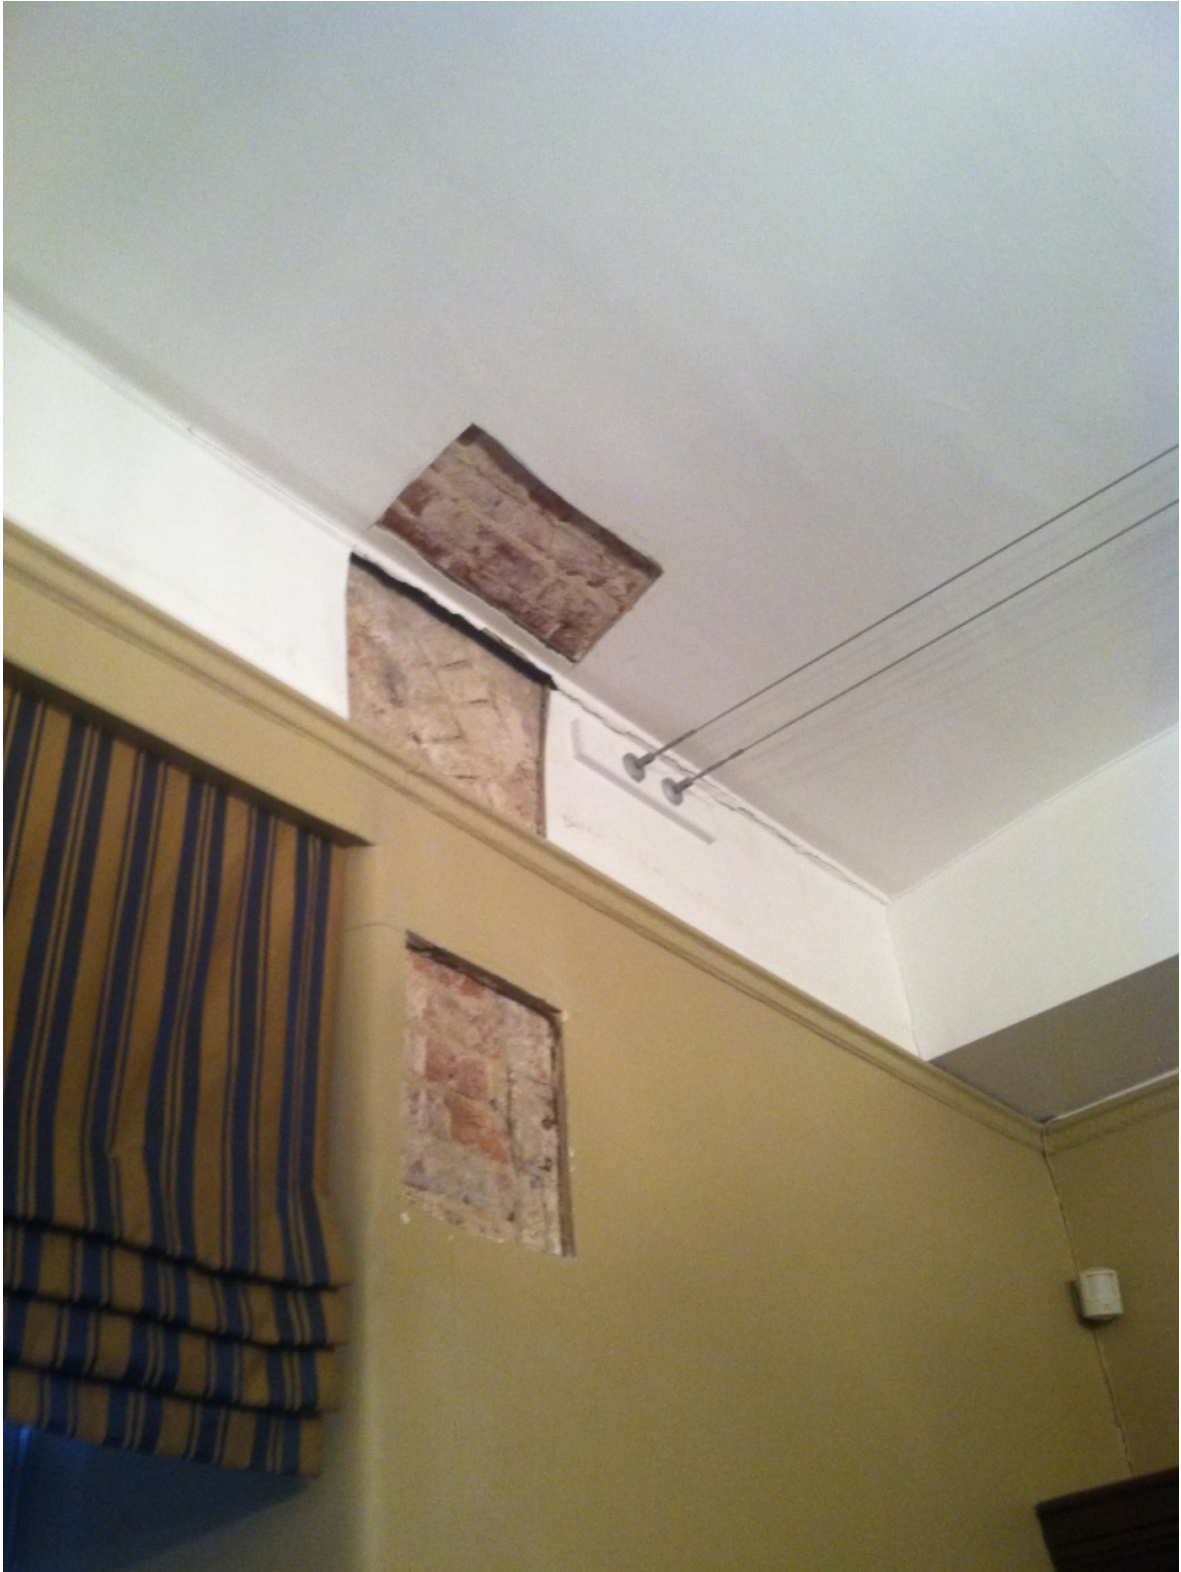
The crack directly above the Secretary's printer, west of the window, appeared to be a result of movement at a joint in the interior with that telegraphed through the plaster (Figure 3). The masonry joint occurs between the brick arch forming the window opening and additional masonry infill that creates the vertical jamb of the window pocket. The arch and the brick jamb are not coursed together and as such there is no mechanical connection between them.

Additionally, the integrity of the masonry infill at the jamb is much less consistent than that of the arch. Seismic accelerations of the building mass likely resulted in much greater horizontal displacements of the more loose brick and mortar at the jamb. The existence of a cavity between the interior brick and exterior stone withes and the observations of the exposed beam flange indicated that the interior masonry is not load-bearing. Based on this, and the fact that the cracks do not appear to extend through the exterior stone, we believe that these cracks do not pose a significant structural concern.

Figure 3: Probe west of window in Secretary's Office ("above the printer" location).

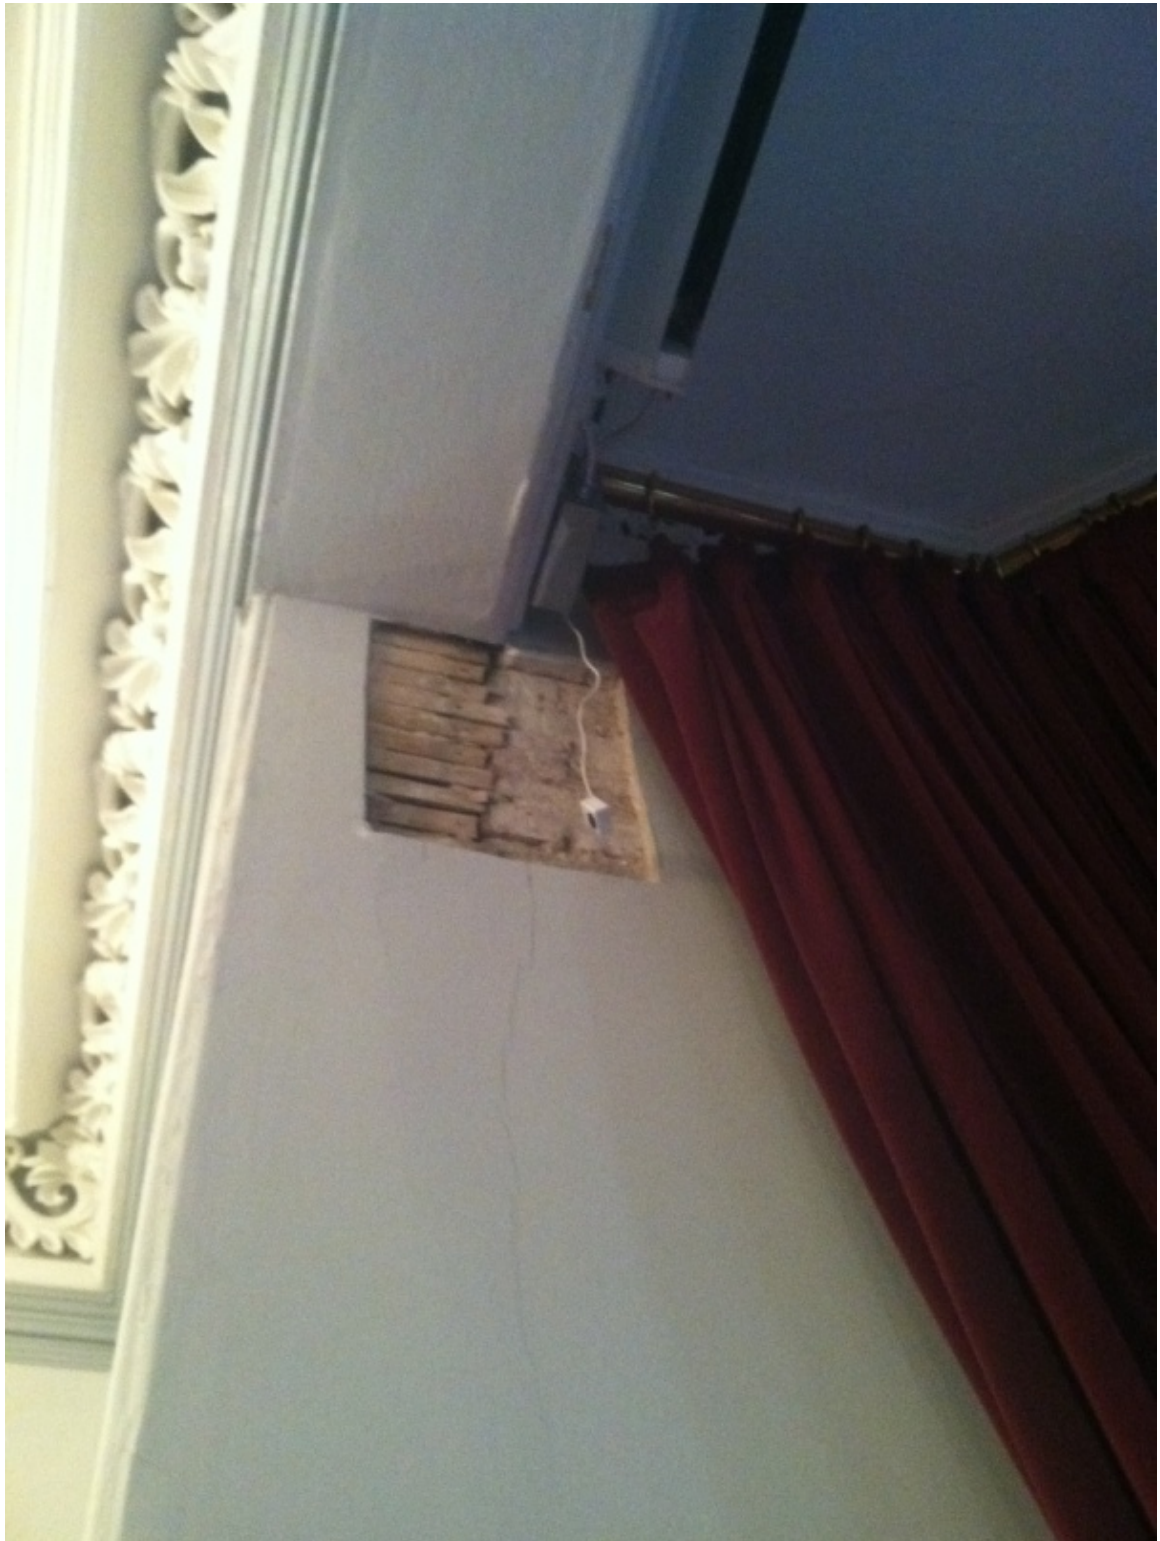
A probe in the Regent's Room was only done on the eastern side of the bay window (Figure 4) opening and similar cracks occurred on the western wall of the opening at the same location. Based on the probes (Figure 5) and previous renovation construction photos (Figure 6), the cracks on both sides of the framed opening at the bay window extension occurred due to discontinuities in the back-up support for the plaster finish.

The plaster on the north side of the crack is applied to wood lathe which is built out in front of the masonry wall. The plaster on the south side of the crack is applied directly to the masonry surface. The differing back up materials creates the condition of a weak vertical plane where they meet. The observed cracks follow this plane closely. Again, these cracks do not indicate any signs of structural distress, and appear to be cosmetic only.

Figure 4: Probe location at eastern side of bay window opening in Regent's Room.

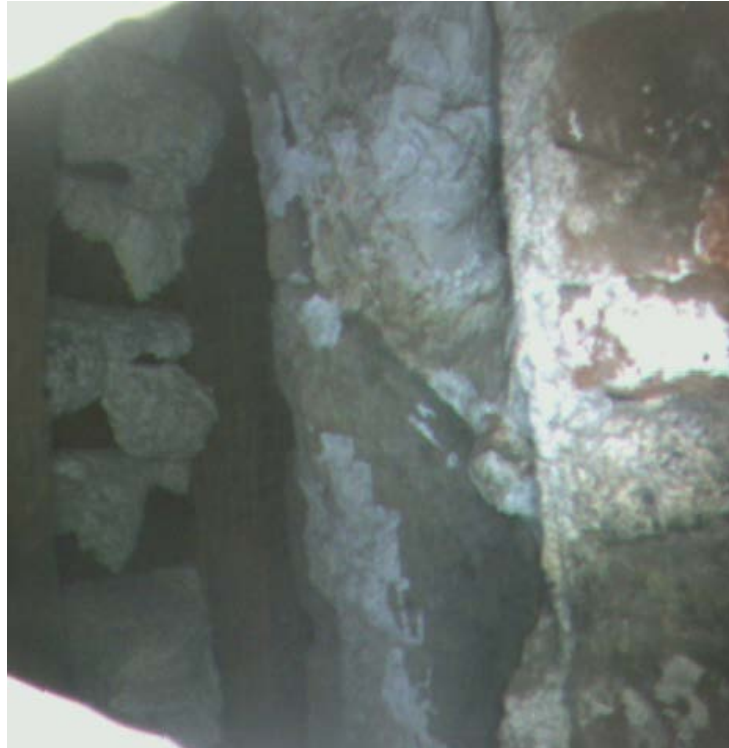
Figure 5: View from scope showing both masonry back-up (to right) and plaster and lathe back-up (to left).

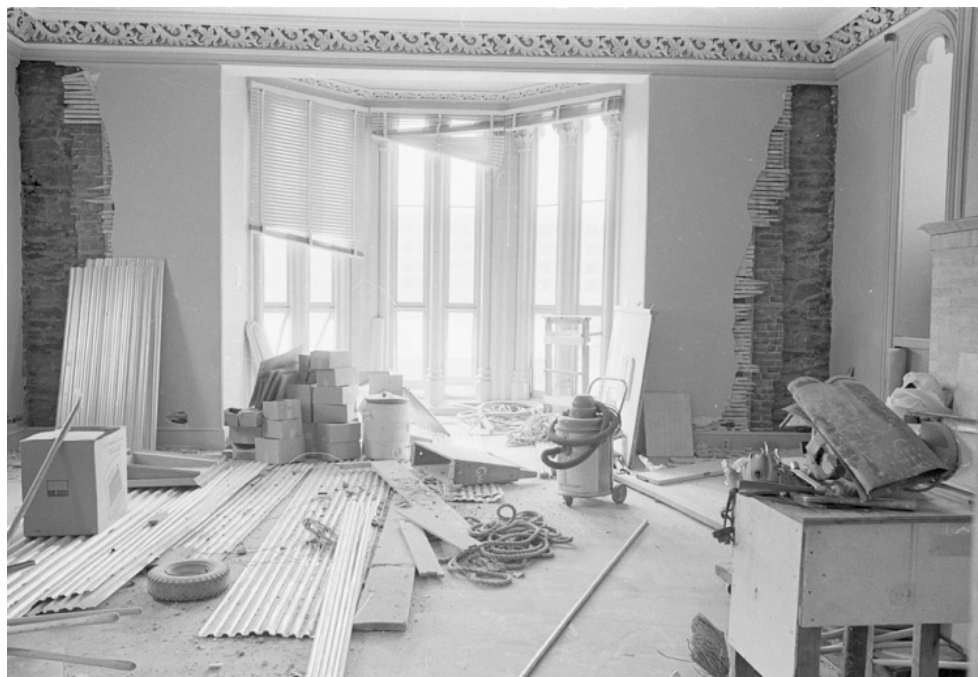
Figure 6: Photo of Regent's Room renovation circa 1968 showing exposed interior wall construction.
